ASBESTOS ASSESSMENT REPORT

**BRIDGE REHABILITATION
- Carl's Straight Path Over
Long Island Expressway (I-495) -
(BIN 1049350)**

TOWN OF HUNTINGTON, SUFFOLK COUNTY
(NYSDOT REGION 10)

August 2013

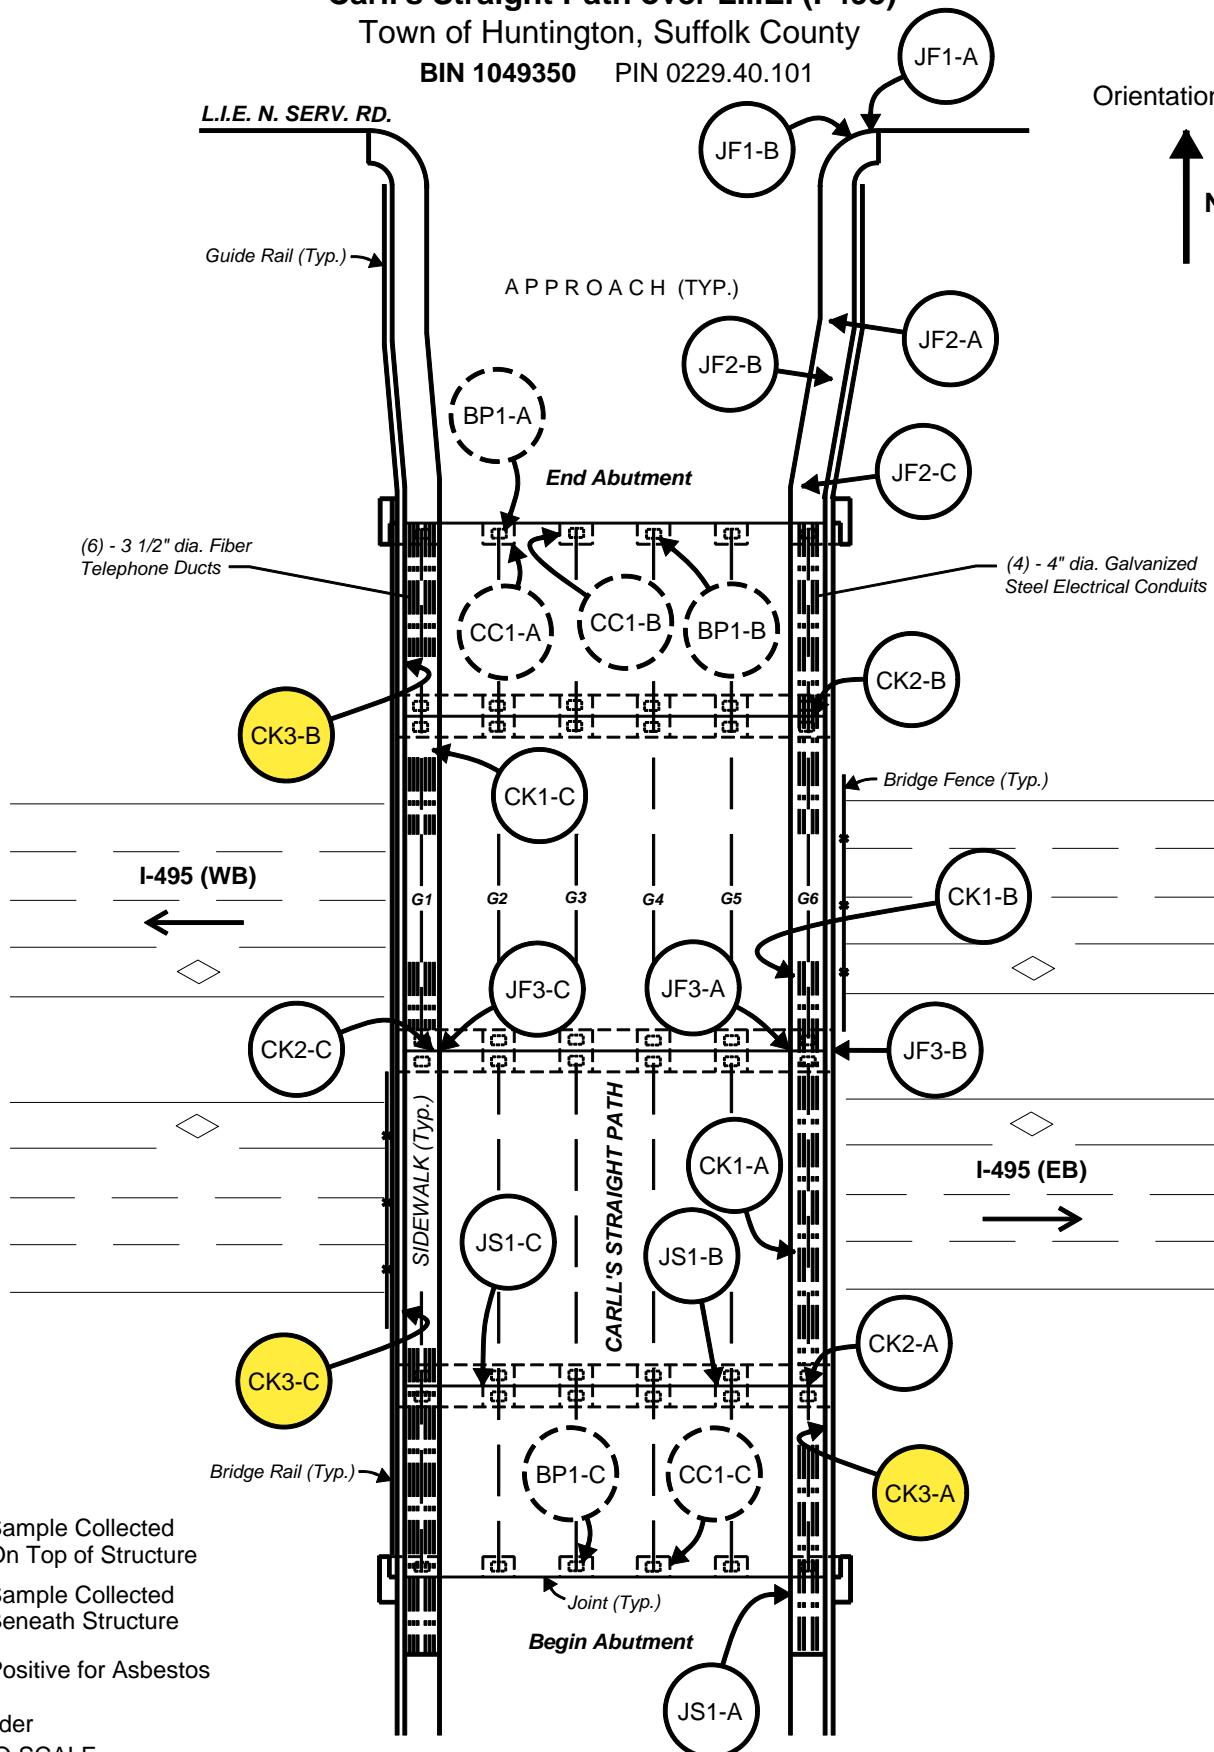
BIN 1049350 PIN 0229.40.101

- Sample Collected On Top of Structure
- Sample Collected Beneath Structure
- Positive for Asbestos

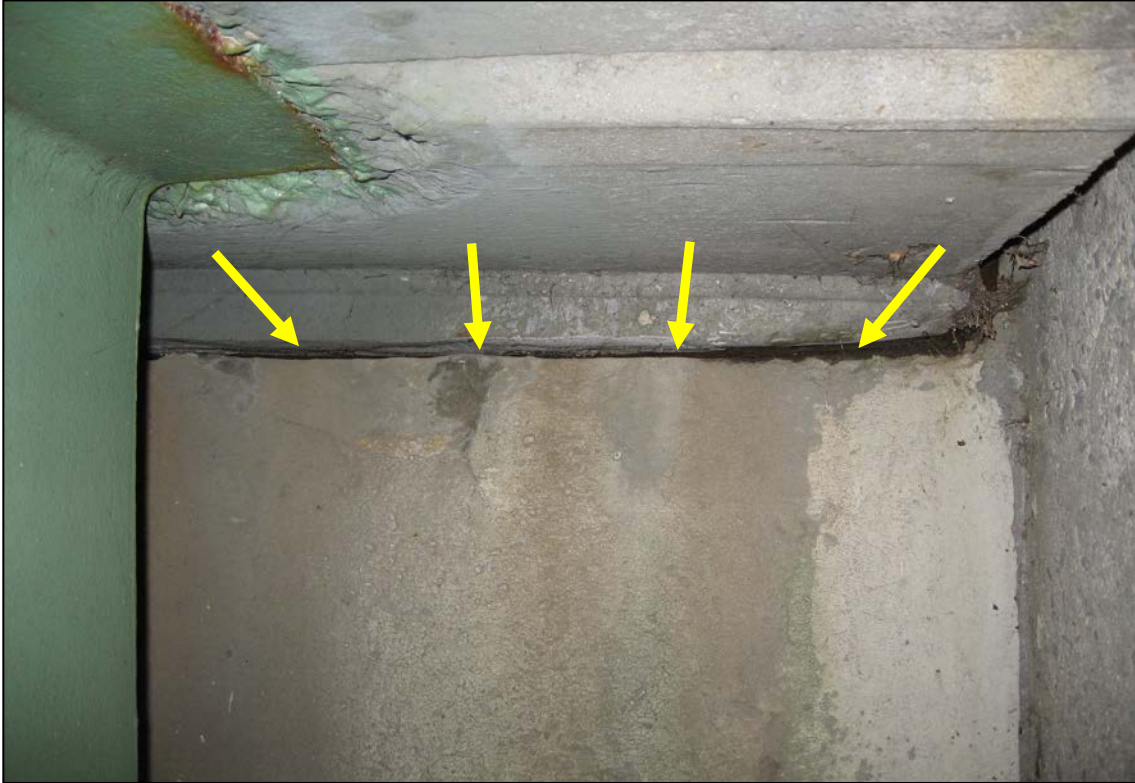
- As indicated on the As-Built Diagrams (1960), the bond breaker slip sheet between the top of the abutment backwalls and bottom of the bridge deck is an asbestos-containing material and, therefore, was not sampled. Visual inspection confirmed the non-friable material to be present and in good condition.

Photo 1 - The bond breaker slip sheet, between the top of the abutment backwalls and bottom of the overlying bridge deck (Typ.), is an ACM as per the record plans. Photo is looking north, at the right side of the End Abutment.

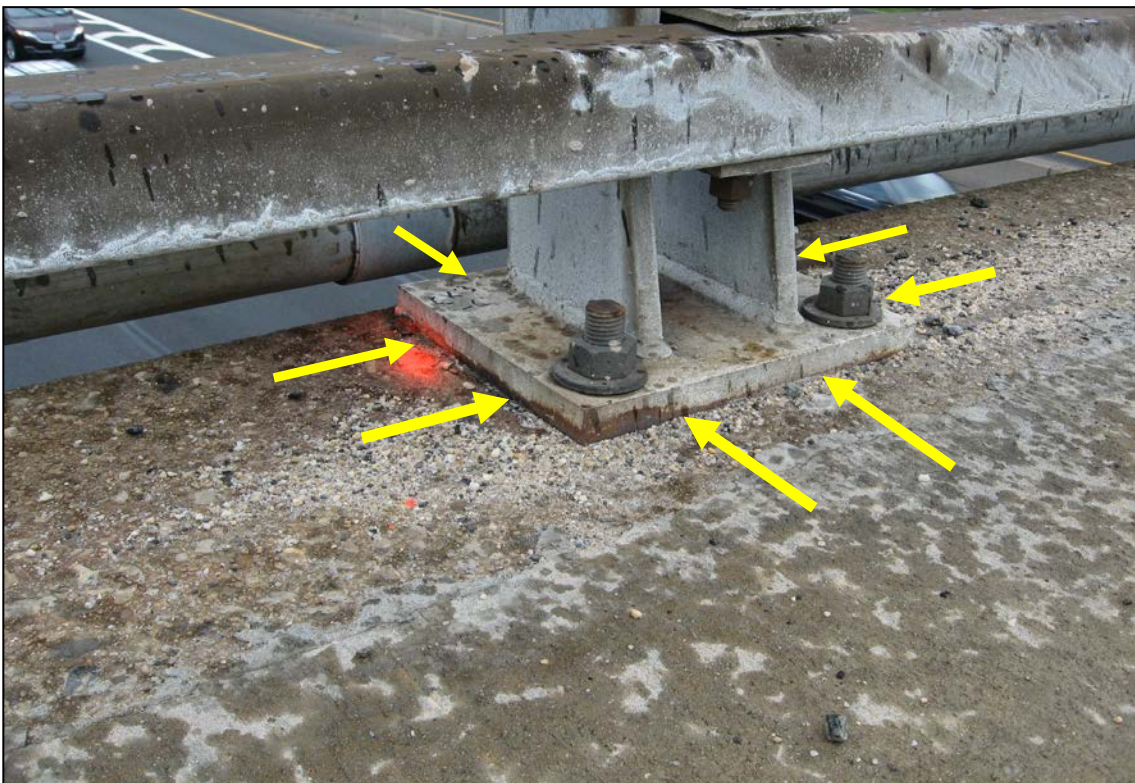
CK3 – Three (3) samples of a firm, dark grey, caulking were collected. This material is present around the base plates of the bridge rail posts. The non-friable material was in fair condition, and not uniformly present.

Photo 2 - The firm, dark grey, caulking (CK3), present around the bridge rail post base plates, is an ACM. Photo is looking west, at sample CK3-C, taken from Rail Post #10, on the left side of the bridge at the beginning of Span 2.

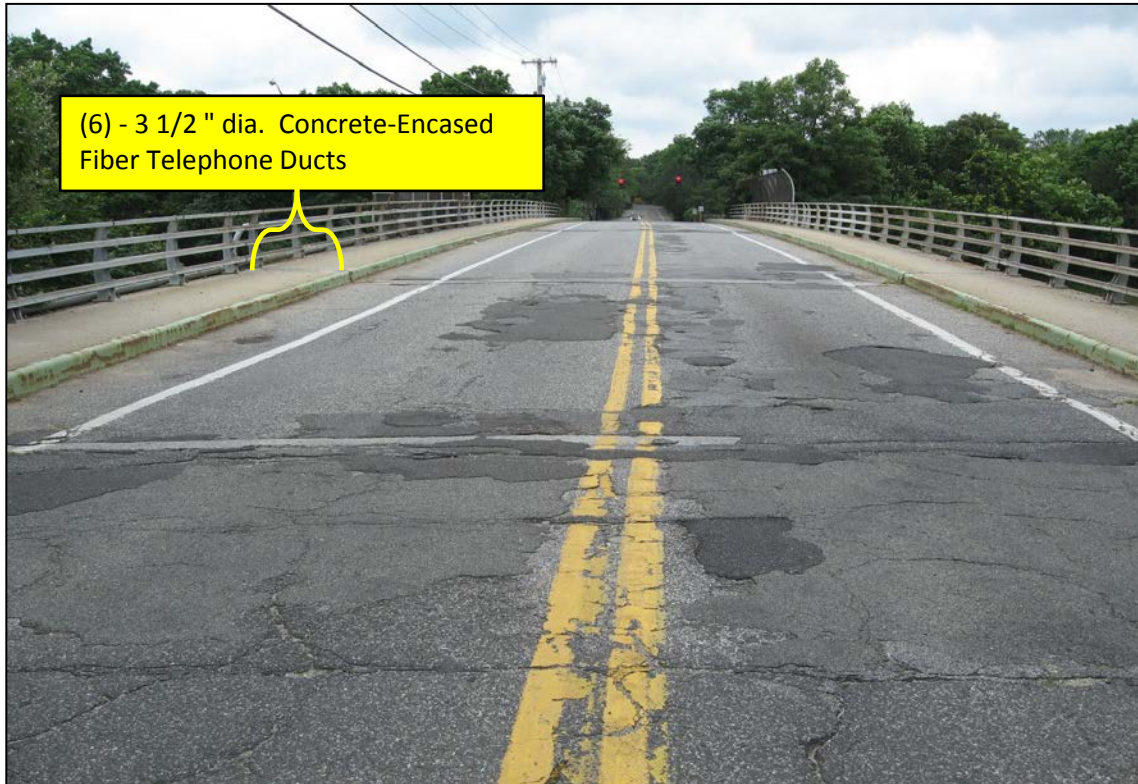
- As indicated on the As-Built Diagrams (1960), there are (6) - 3½" dia. Fiber Telephone Ducts encased in concrete underneath the left (west) sidewalk of the bridge. Due to inaccessibility, this suspect asbestos-containing material (SACM) was not observed or sampled. However, as indicated by the Region, abatement of this material will be the responsibility of the utility company.

Photo 3 - As indicated on the record plans, the (6) - 3 1/2" dia. Concrete-Encased Fiber Telephone Ducts, underneath the left (west) sidewalk, is a SACM. Photo is looking north, across the bridge deck, from the Begin Abutment.

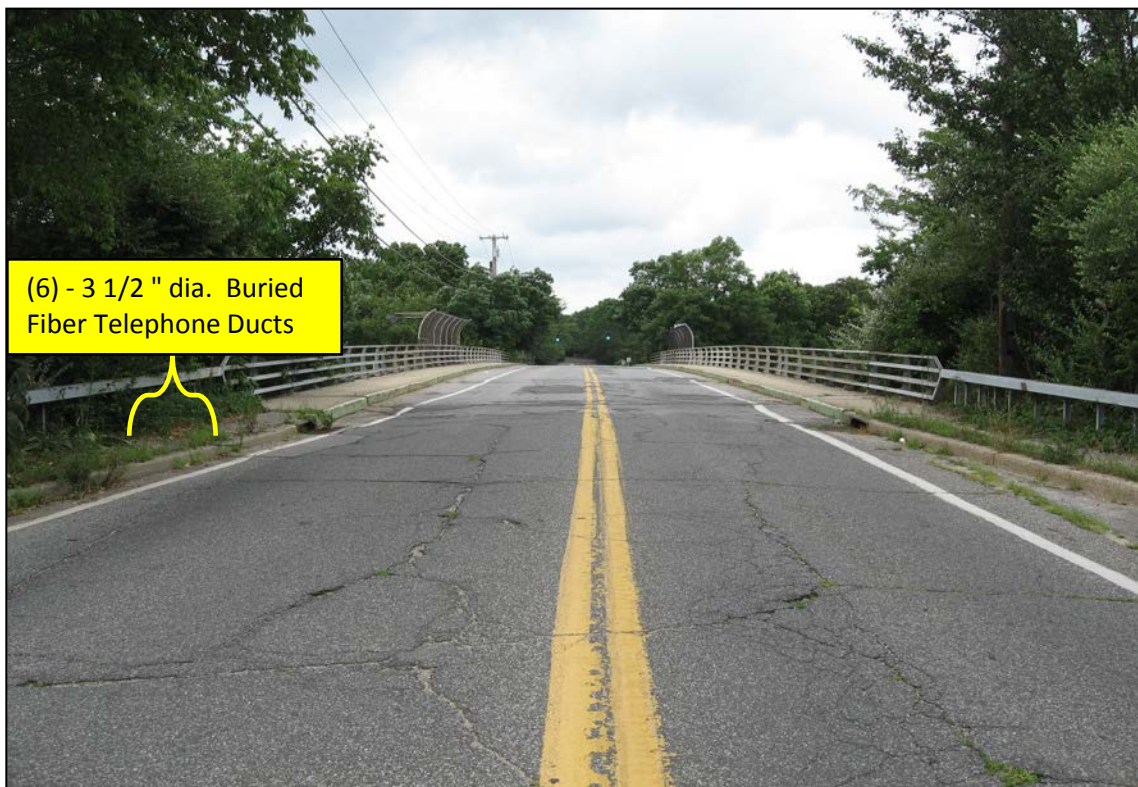
- It is assumed that the Concrete-Encased Fiber Telephone Ducts underneath the left (west) sidewalk extend under both approach road sidewalk/grass areas as buried pipe. Due to inaccessibility, this suspect asbestos-containing material (SACM) was not observed or sampled. However, as indicated by the Region, abatement of this material will be the responsibility of the utility company.

Photo 4 - It is assumed that the (6) - 3 1/2" dia. Concrete-Encased Fiber Telephone Ducts, underneath the left sidewalk of the bridge, extend under the grass area along the left side of the Begin Approach road, to the north side of the L.I.E. S. Serv. Rd., as buried pipe. Photo is looking north, towards the Begin Abutment.

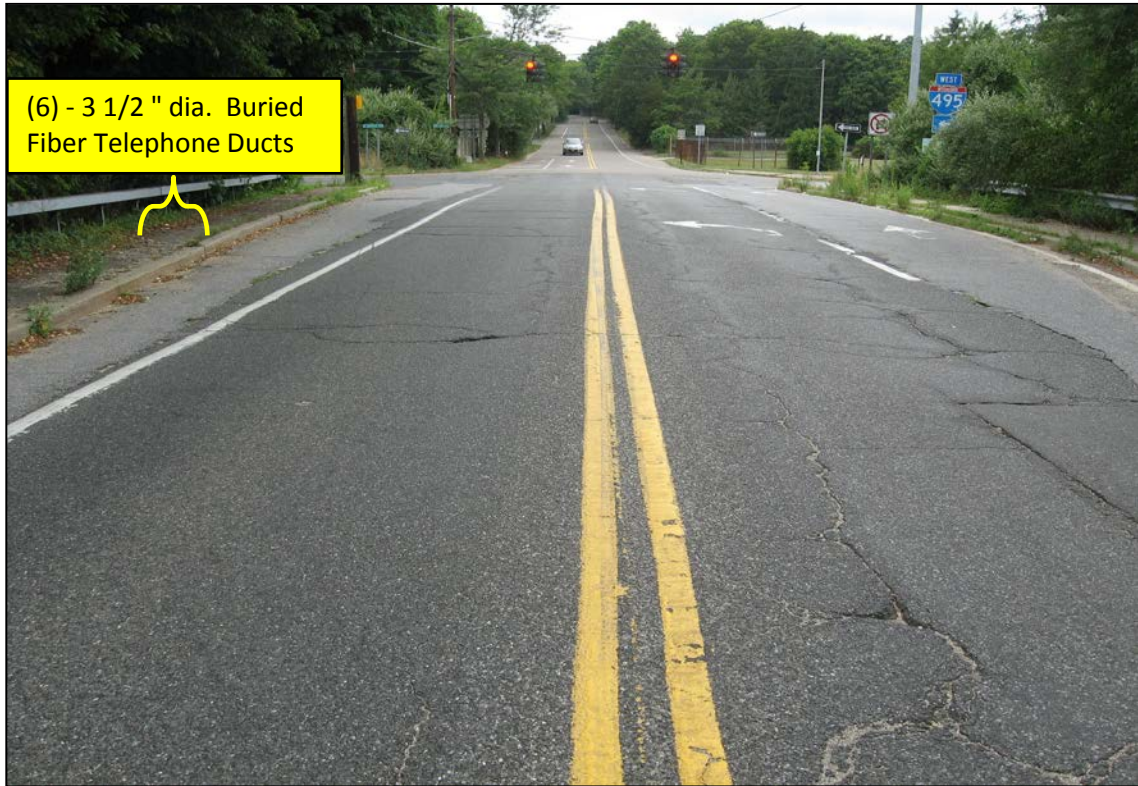
Photo 5 - It is assumed that the (6) - 3 1/2" dia. Concrete-Encased Fiber Telephone Ducts, underneath the left sidewalk of the bridge, extend under the asphalt path along the left side of the End Approach road, to the south side of the L.I.E. N. Serv. Rd., as buried pipe. Photo is looking north, from the End Abutment.
